DEPARTMENT OF TRANSPORTATION

Quality Assurance and Source Inspection

Contract #: 04-0120F4Cty: SF/ALA Rte: 80 PM: 13.2/13.9File #: 99.28**WELDING INSPECTION REPORT****Resident Engineer:**Siegenthaler, Peter**Address:** 333 Burma Road**City:** Oakland, CA 94607**Report No:** WIR-025139**Date Inspected:** 04-Jul-2011**Project Name:** SAS Superstructure**OSM Arrival Time:** 700**Prime Contractor:** American Bridge/Fluor Enterprises, a JV**OSM Departure Time:** 1900**Contractor:** Zhenhua Port Machinery Company, Ltd (ZPMC), Changxing Island **Location:** Shanghai**CWI Name:****CWI Present:****Yes No****Inspected CWI report:** **Yes No N/A****Rod Oven in Use:****Yes No N/A****Electrode to specification:** **Yes No N/A****Weld Procedures Followed:****Yes No N/A****Qualified Welders:** **Yes No N/A****Verified Joint Fit-up:****Yes No N/A****Approved Drawings:** **Yes No N/A****Approved WPS:****Yes No N/A****Delayed / Cancelled:****Yes No N/A****Bridge No:** 34-0006**Component:** OBG**Summary of Items Observed:**

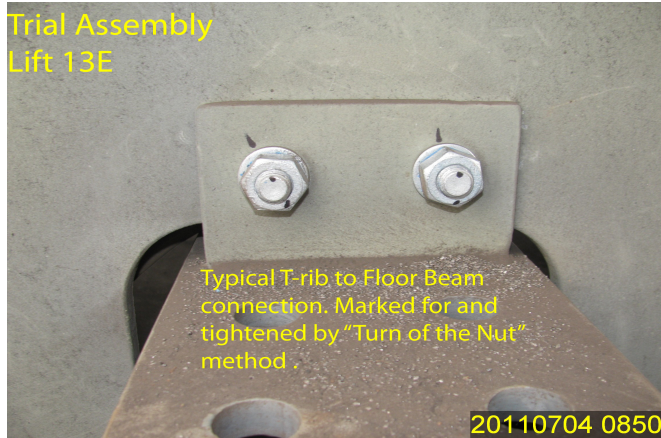
This QA Inspector witnessed the final bolt tension verification on bolts connecting the T-rib clips between Bottom and side plate stiffeners to Floor Beams at Panel Point (PP) 117.5 for Segment 13AE. The QA Inspector verified the bolt tension on a random basis and the results appeared to be in general compliance. The Inspection was performed against Notification No. 00686 dated July 4, 2011.

The bolt sizes used were M16 x 50 RC Lot # DHGM160004 and the final torque value established was 200 N-m.
